## **Bose 6 pack CD AUDIO cut out repair**

by: Chris.s@TMEC

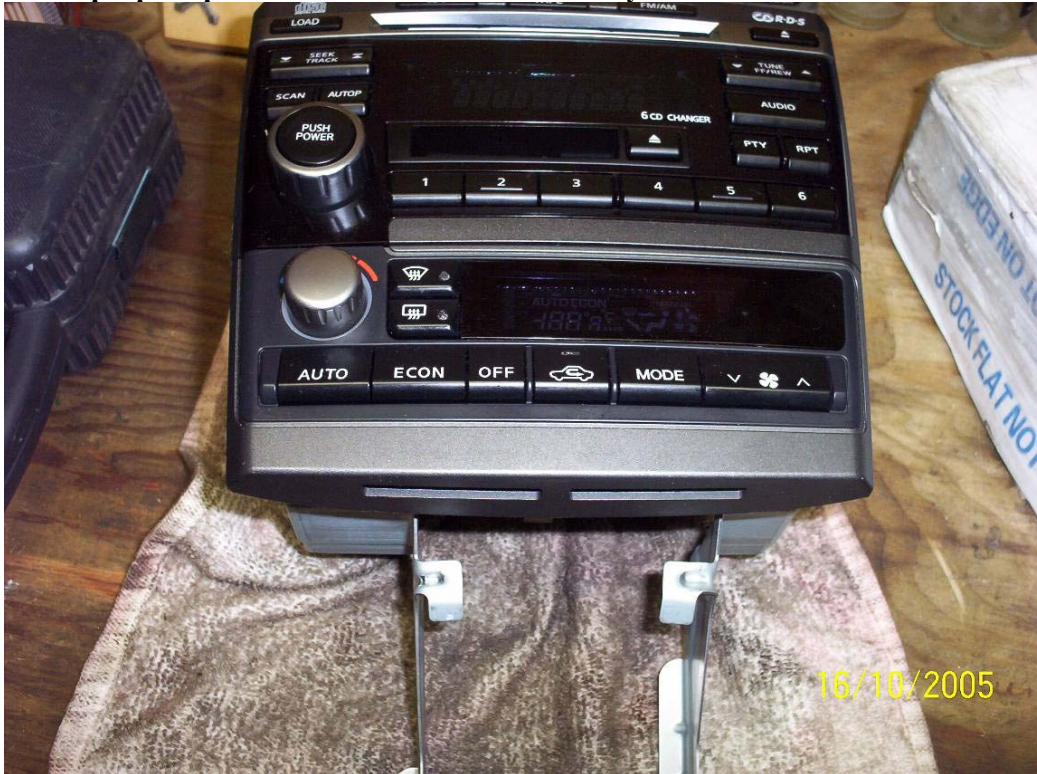
5. Once you remove the 4 screws from the HU bracket pull the unit outwards and prop it up on either the shifter or dash so you can remove the harnesses.

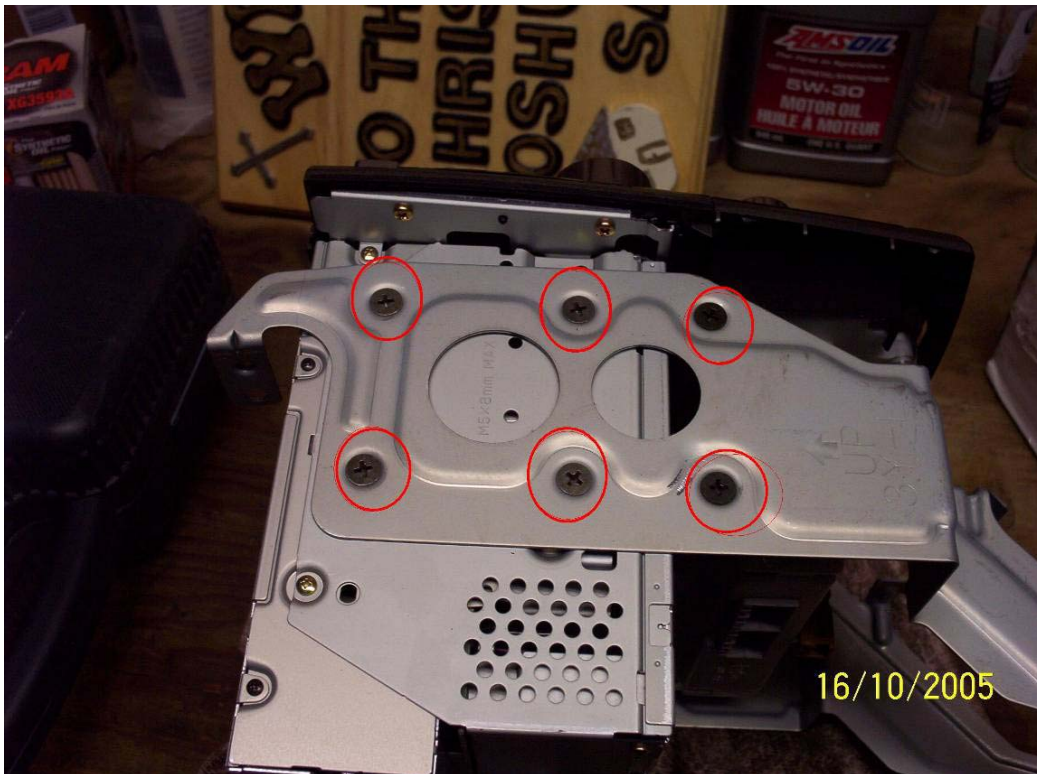
**Stereo and climate control units removed from vehicle**

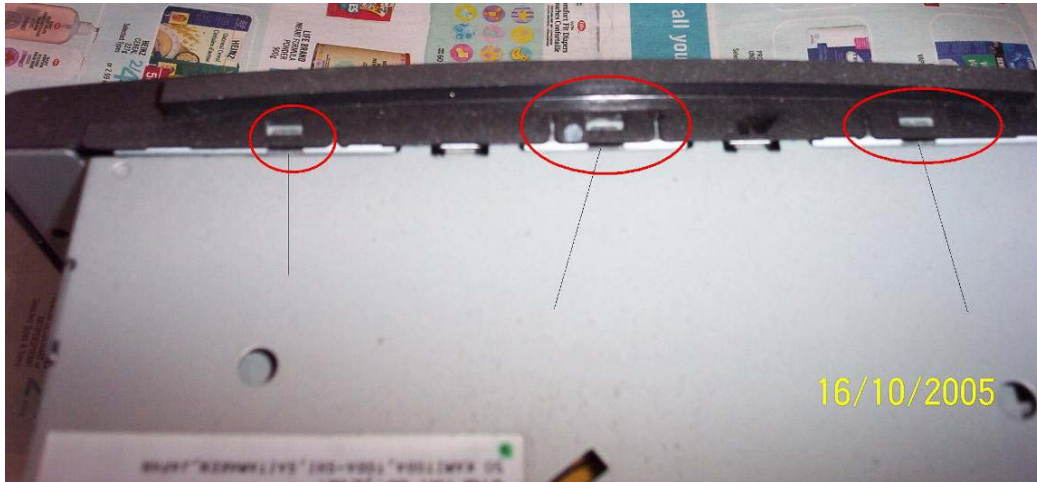
**Remove...**

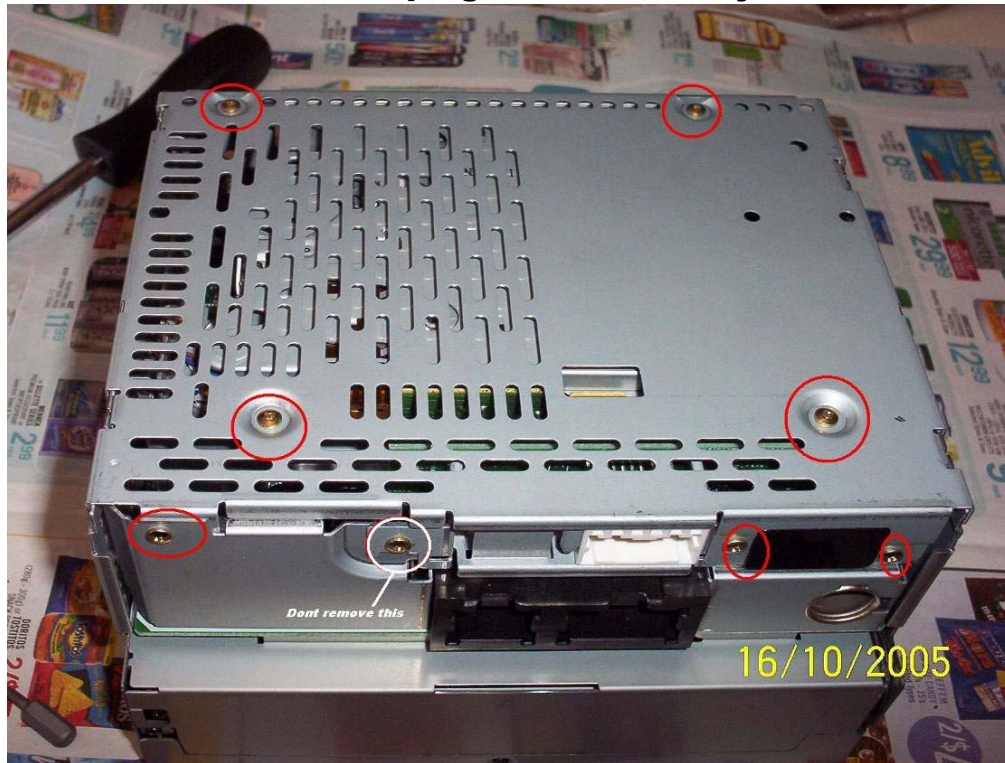
**Remove these. Don't remove the one circled in white**

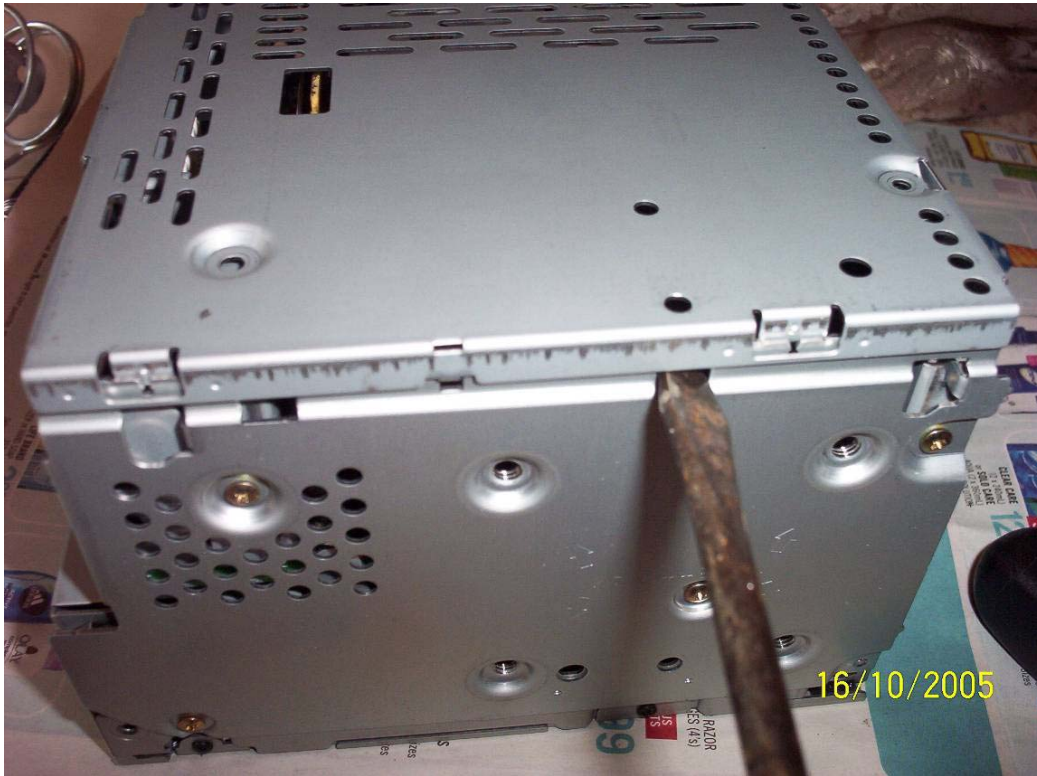
**Use a screw driver to pop the plate off.**

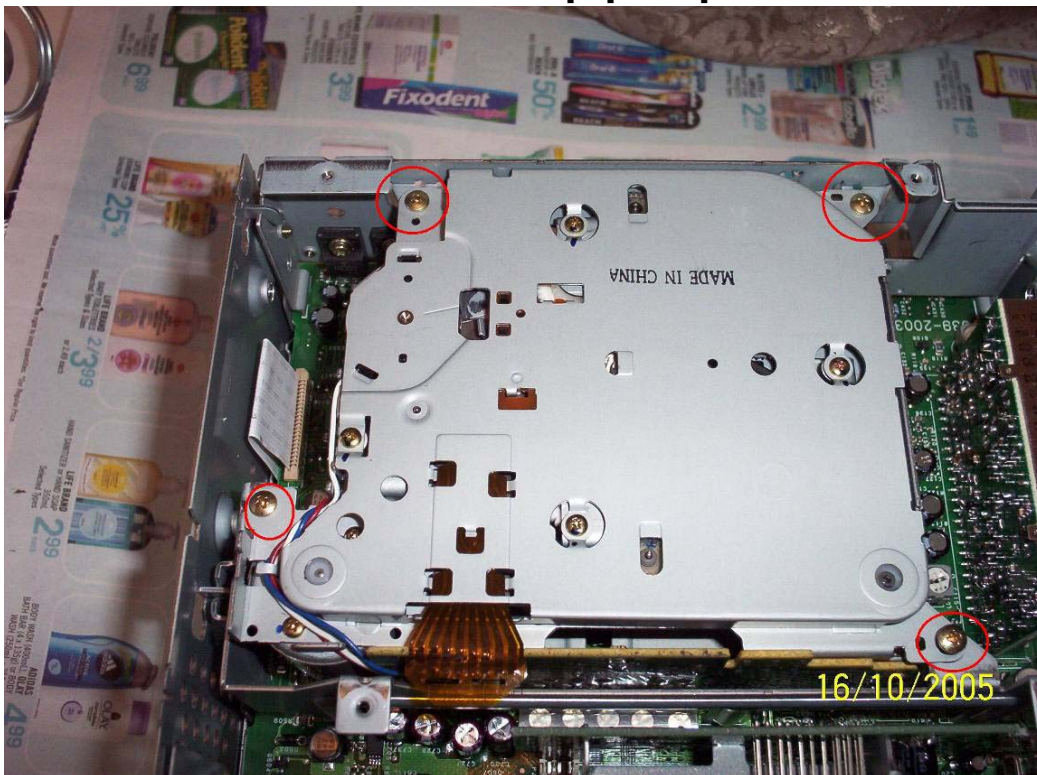
**Once inside, remove the tape deck by removing the 4 circled screws and pulling up on the tape unit.**

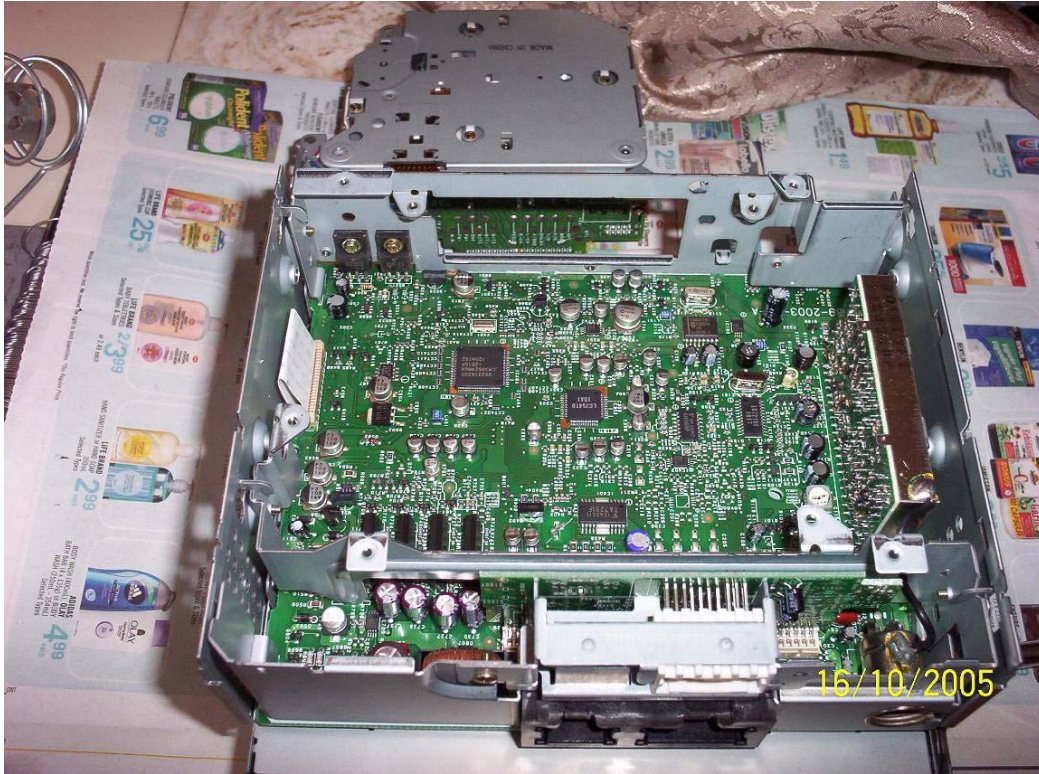
**With tape deck removed....**

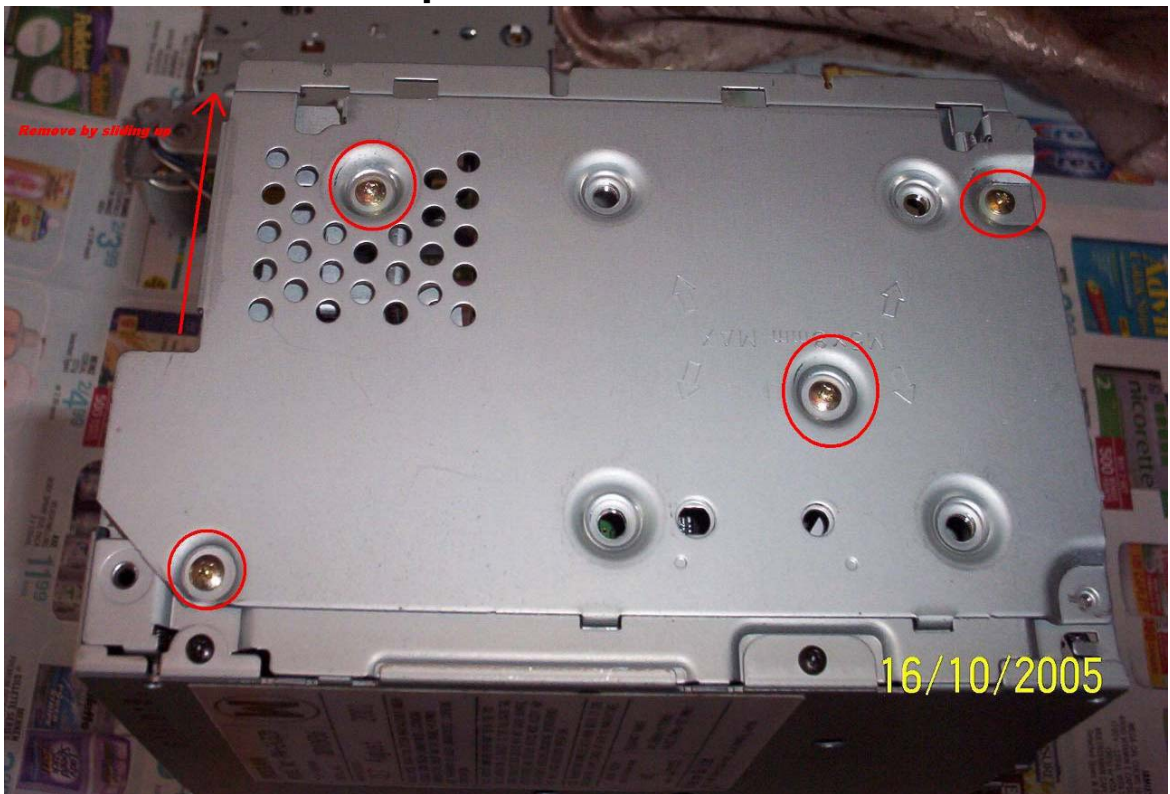
**Remove the screws holding the 2 side plates on. Remove these plates by sliding them upwards. (opposite side not shown)**

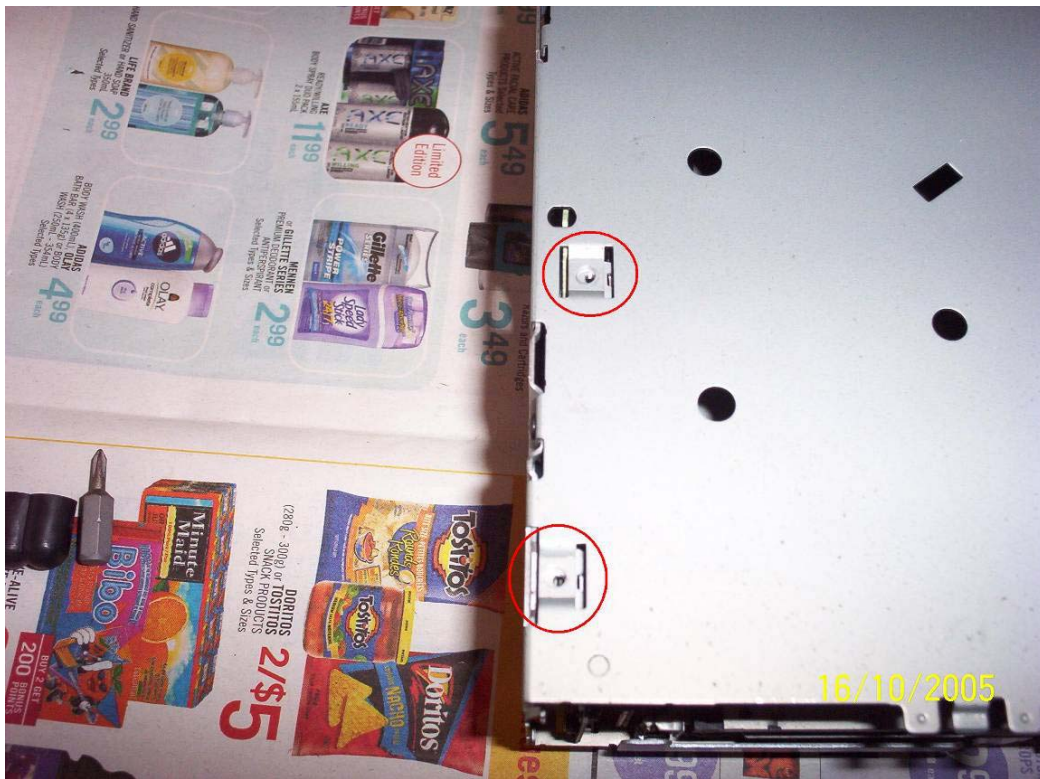
**Begin removing the screws from the CD changer cover....**

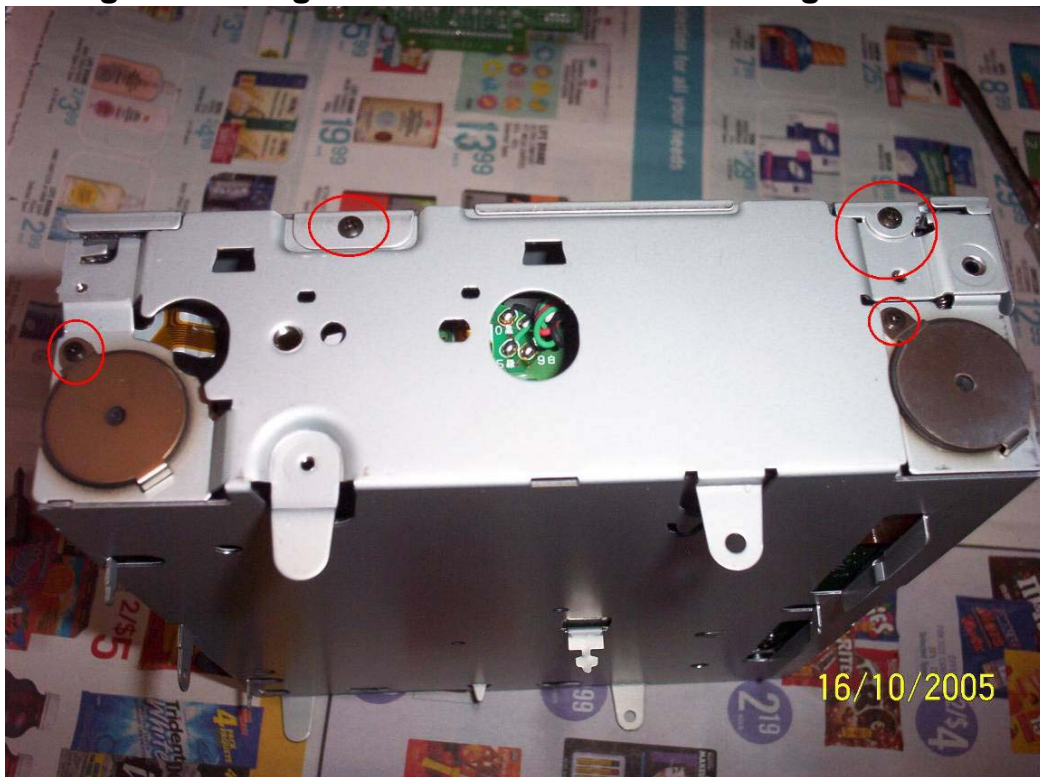
**CD Changer with cover off...**

**Note:**

**The 2 plastic posts on either side of the laser "May" fall out during handling. Simply put them back before reassembly.**

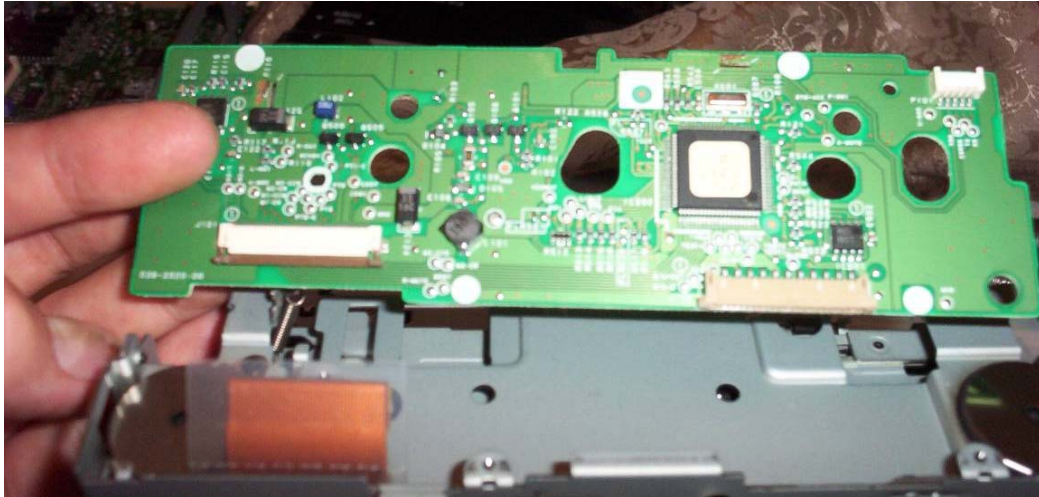
**Put this aside.**
